# . BUREAU OF SHIPS GROUP TECHNICAL INSPECTION REPORT

U.S.S. RALPH TALBOT (DD390)

OPERATION CROSSROADS

#### TECHNICAL INSPECTION REPORT

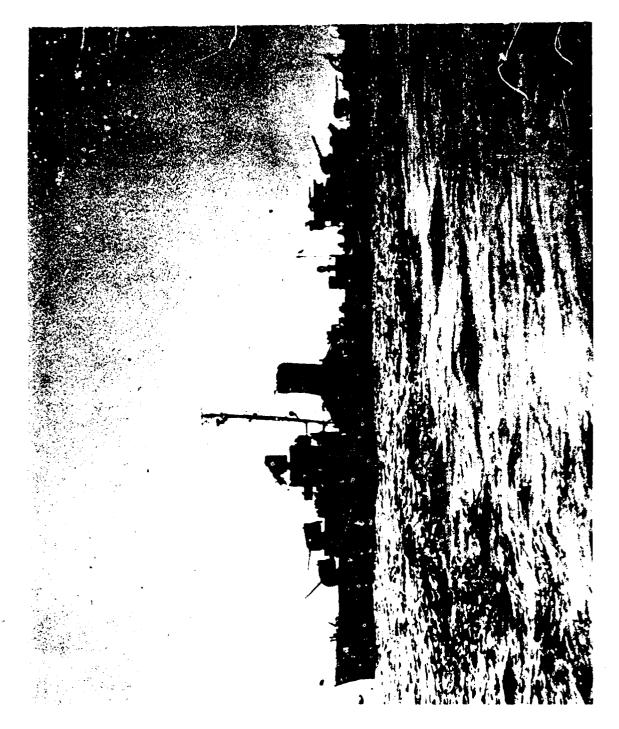
BB-CR-227-513-52. Port beam before Test B.

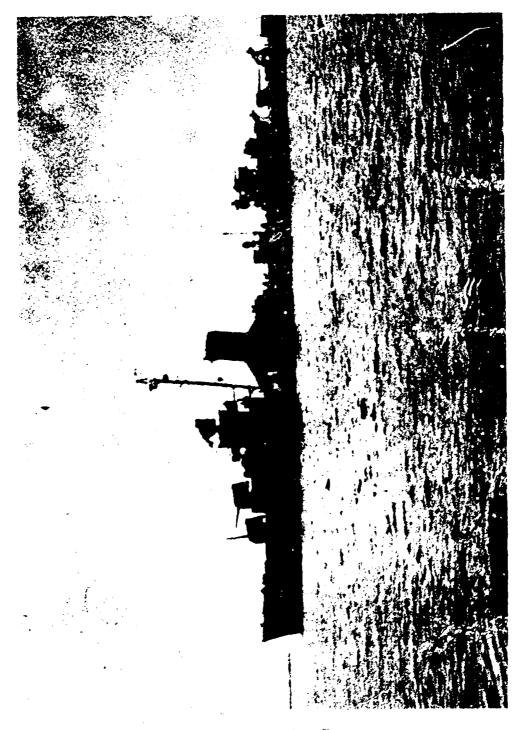
There is no apparent hull damage. Minor normal leakage was noted in the engine room and sound room. Draft readings and list prior to and following the blast were the same. General views of the ship are on pages 19 to 32.

AB-CR-227-243-17. Port beam after Test B.

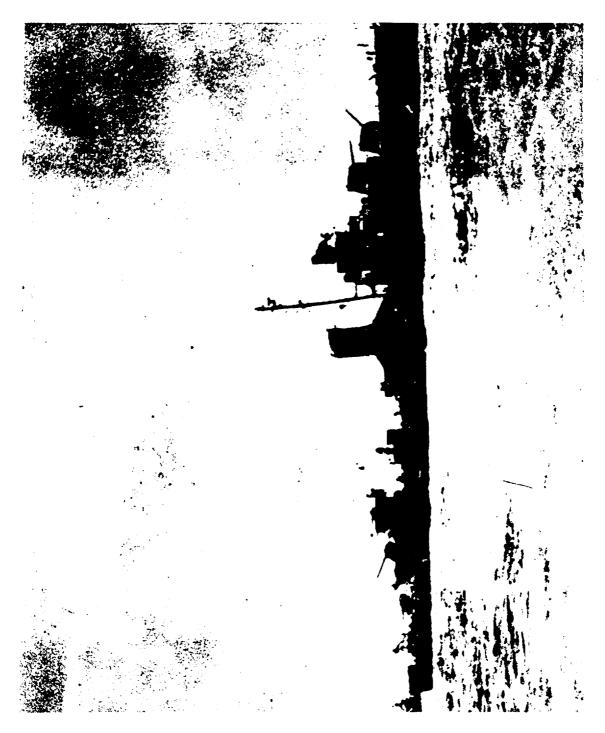
BB-CR-227-513-48. Starboard beam before Test B.

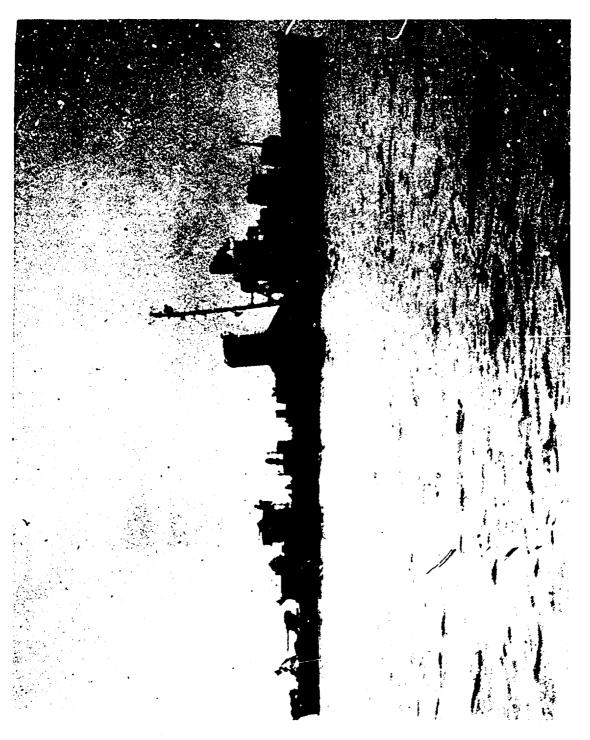
AB-CR-227-243-24. Starboard beam after Test B.
